BTIS

Concrete reconstruction and crack injection is our business

MegaBond®-Injection-Process **Low pressure-Injection-Process**

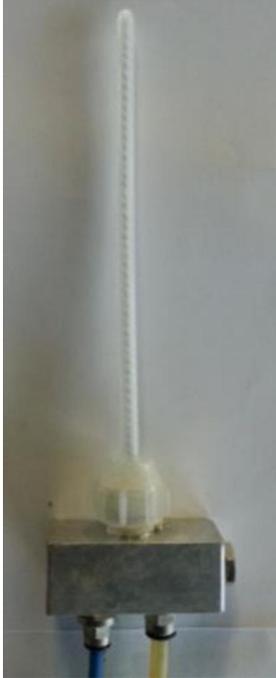
This is our mixer head, in which the components of the resin are mixed shortly before the injection

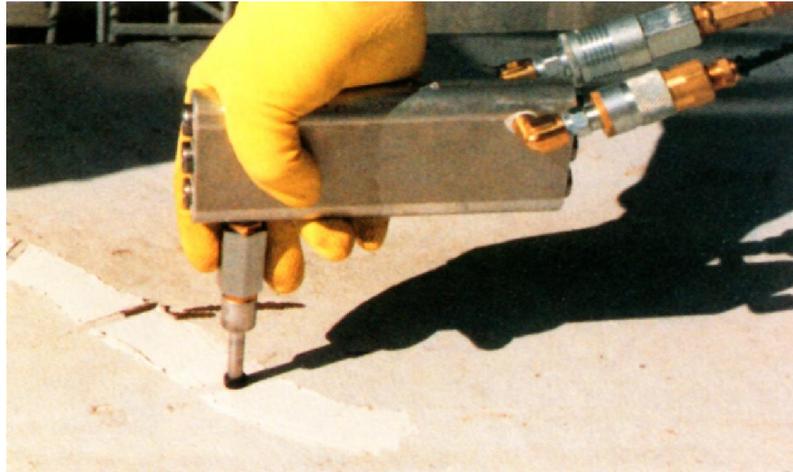
Example of an injection-pump. This pumps the components to the mixer head, in which, only then the mixing takes place. The pump controls the set pressure of the injection and automatically starts pumping when the set pressure drops.

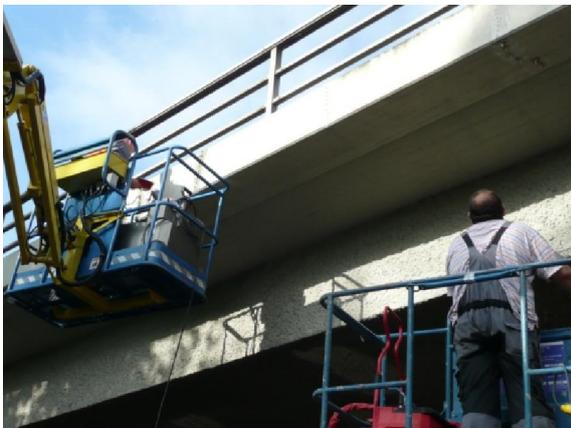
2) Preparation of the cap area for crack injection. The cap was cracked right through to the bottom area and was fully restored with the MegaBond®-Injection-Process.

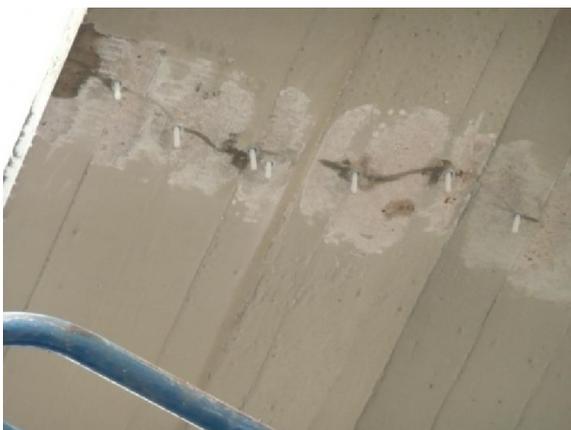
3) Preparation of crack injection in the cap area. Because the cap area was cracked right through, the clip pins were set from the bottom and injected from there.

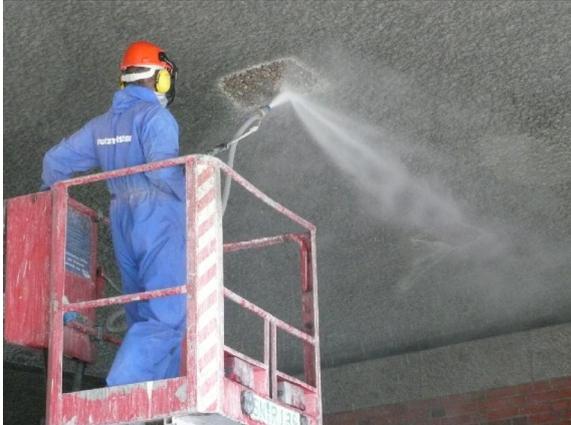
1) High pressure water jet as per ZTV-ING to expose the hollow areas and the corroded steel-reinforcement.

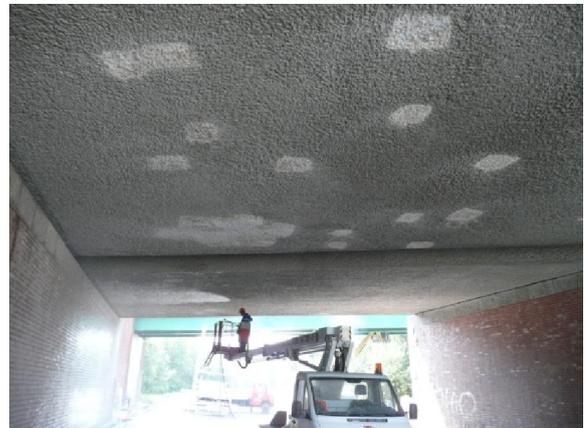
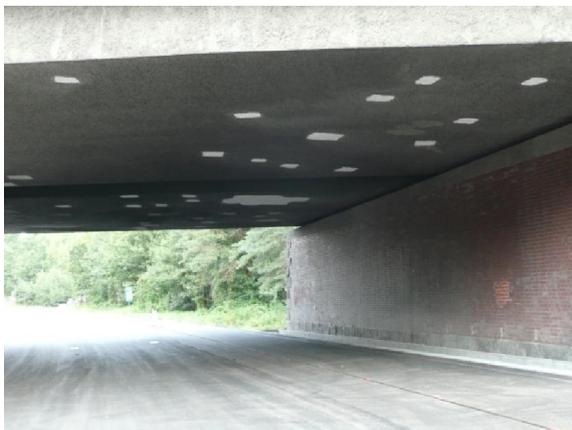
3) Finished renovation of the underpass after high pressure water jets, foundation, first and second coating

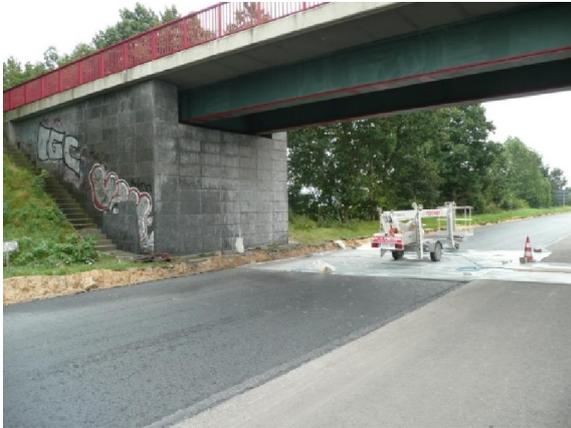
1) Bridges steel carrier beam with first, red coating of corrosion protection after high pressure water jets as per ZTV-ING had cleaned away the damaged old corrosion protection.

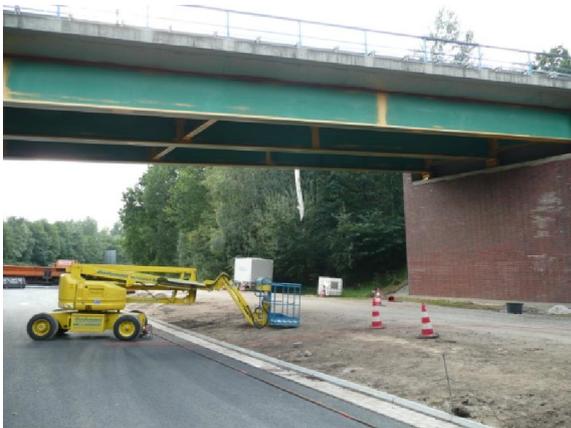
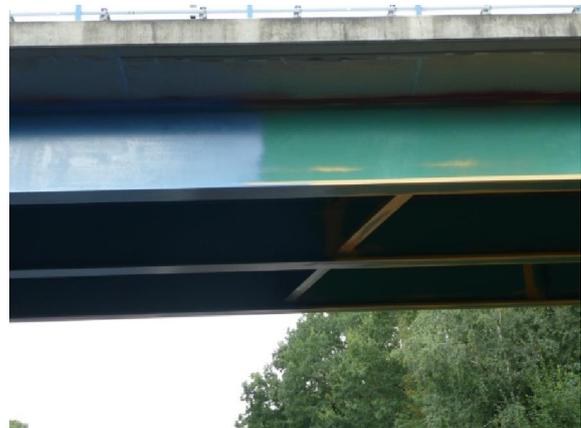
2) Bridges steel carrier beam coated with second layer of corrosion protection in yellow as per ZTV-ING and the next step in transition the blue coating (right picture)

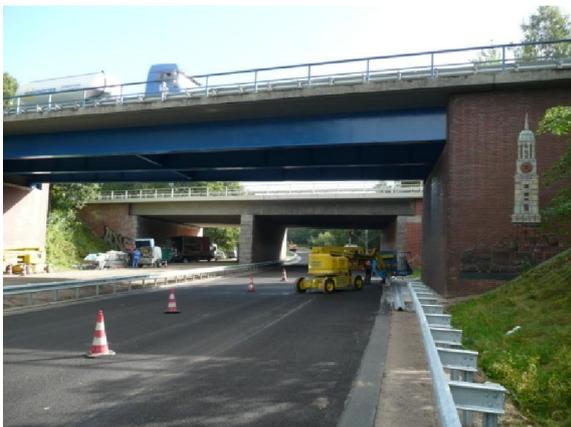
3) Bridges steel carrier with completed corrosion protection in blue.

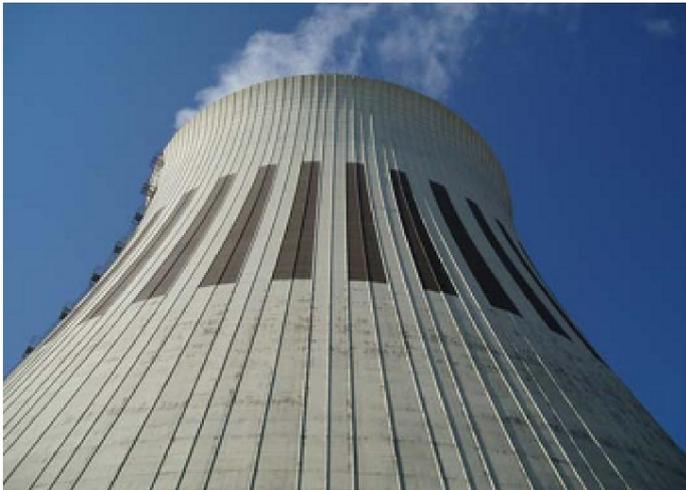
The cracks in the basin wall from only 0,6 mm had to be fixed in order to avoid the cooling water to press forward and to cause damage. For this all of the cooling water of one half of the cooling tower had to be drained.

The complete cooling water of one half of the cooling tower had to be drained to be able to check the cracks in the basin wall. Even though the cracks were only 0,6 mm wide the danger existed that the cooling water would advance to the reinforcement and cause damage. The right task for our MegaBond®-Injection-Process.

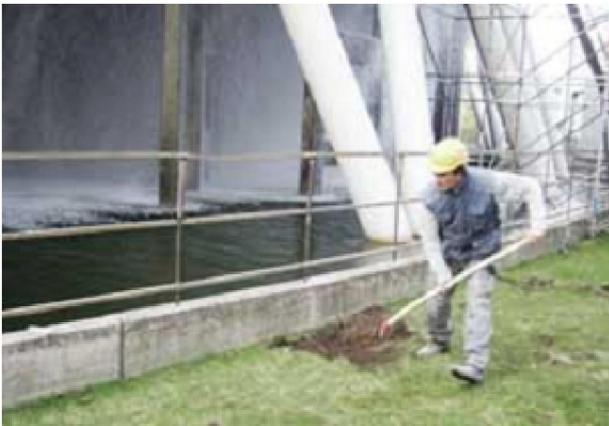
2) Without disturbing the production of the cooling tower a crack was injected at the basin wall.

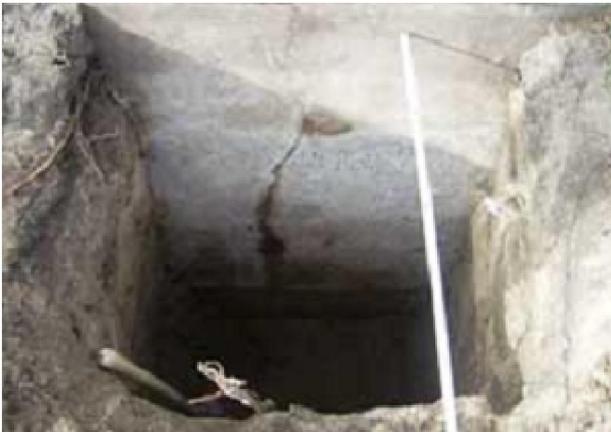
3) After the excavation it is clearly visible, the crack carries water

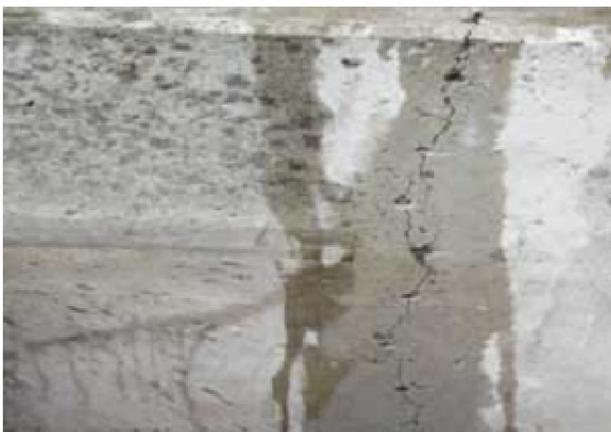
4). Here we will fit our drill clip pins which will be drilled 10 mm deep into the crack with a wet diamond drill of 13 mm

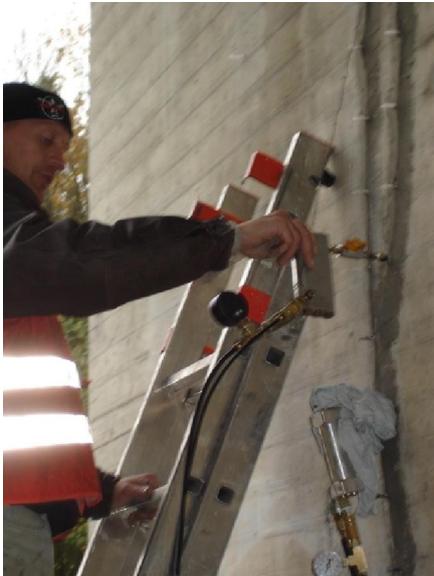
1) MegaBond®-Injection-Process, injection with two injection pistols. It was necessary to inject 800 – 1000 mm into the counterforts.

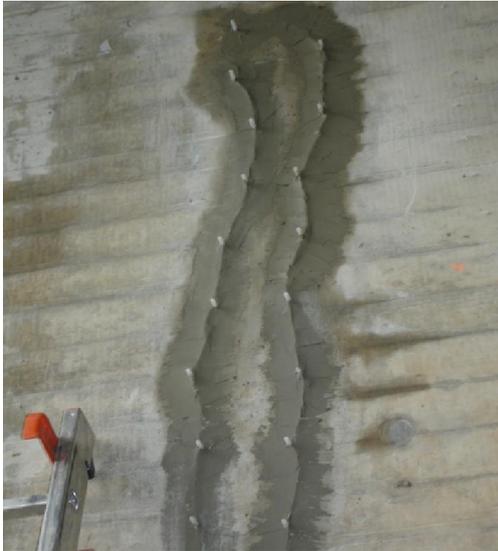
3) As the cracks were partially blocked up a core drill was used to drill 10 mm deep into the material to set our special clip pins.

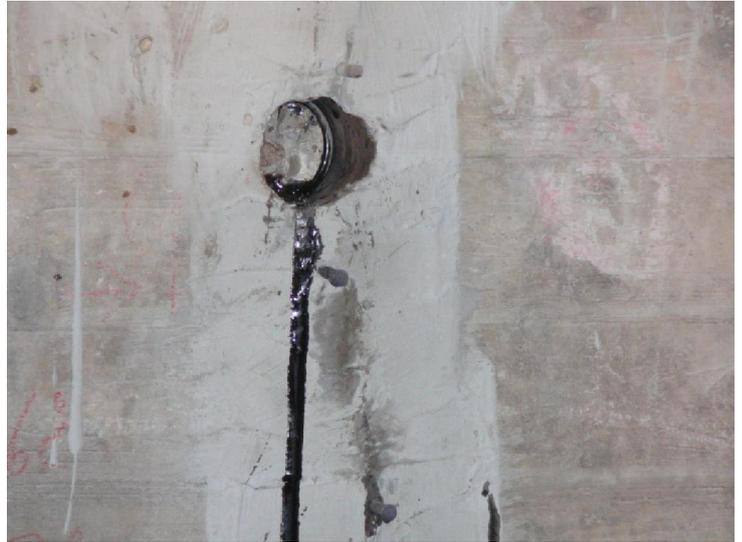
4) After the core was taken out the drill hole, one can see the resin running out the drill hole.

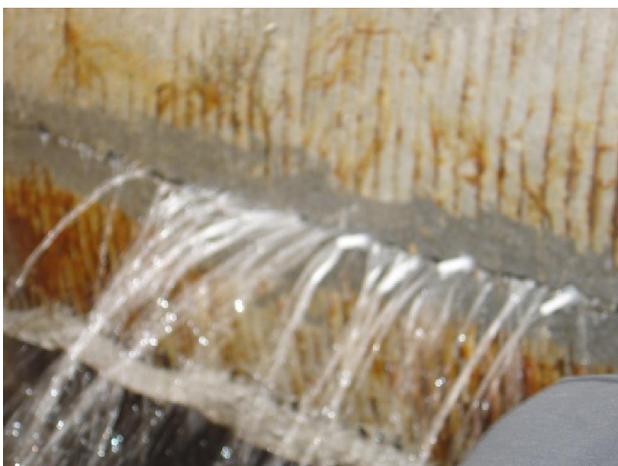
3) The first clip pins was fixed to the crack.

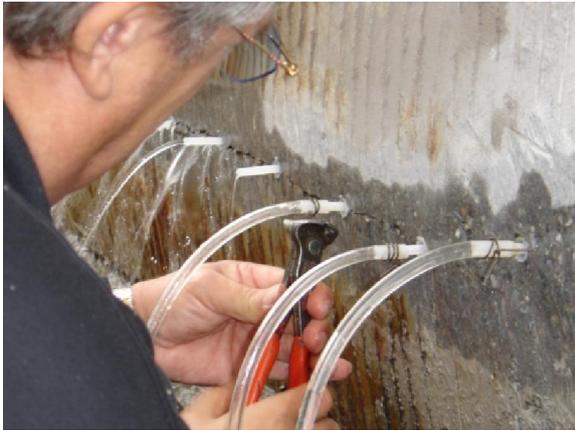
4) The relief or alternatively the injection pipes are fixed to the clip pins.

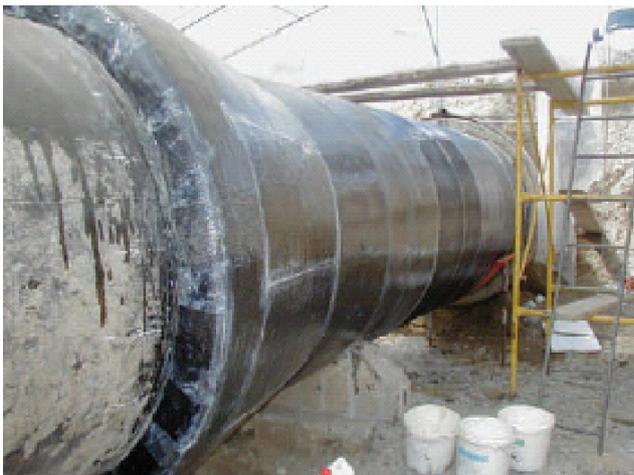
6) To restore the outer coating a carbon-fibre with epoxy resin was used.

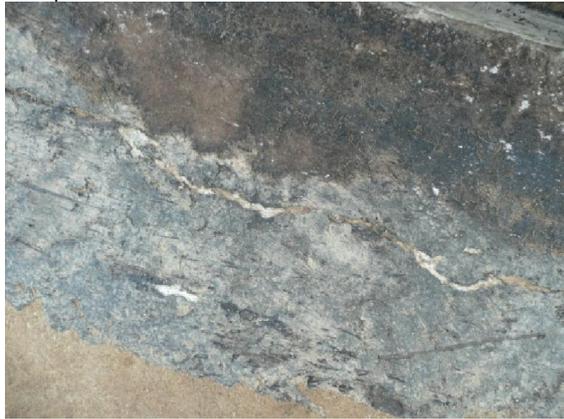
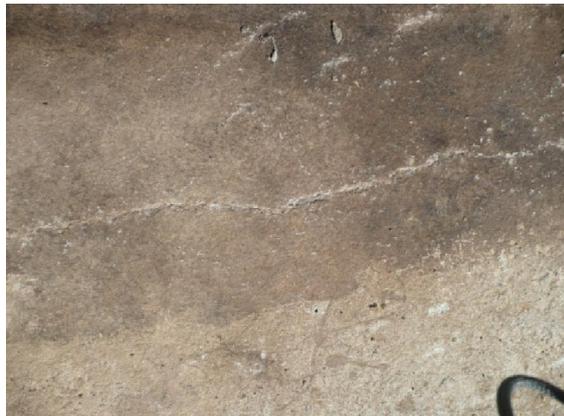
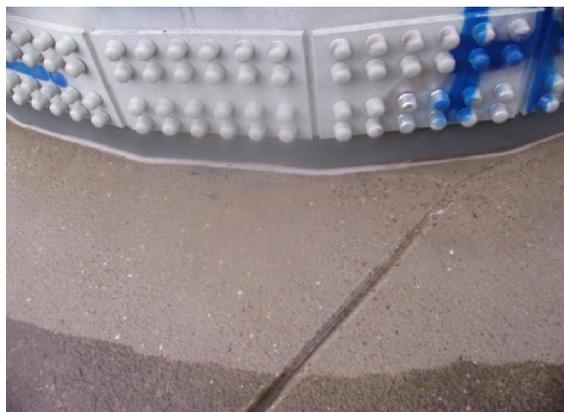
The speed of wind threatened to lift the wind turbine out of the cracked foundation.

There is no sealant on the surface, therefore cracks developed.

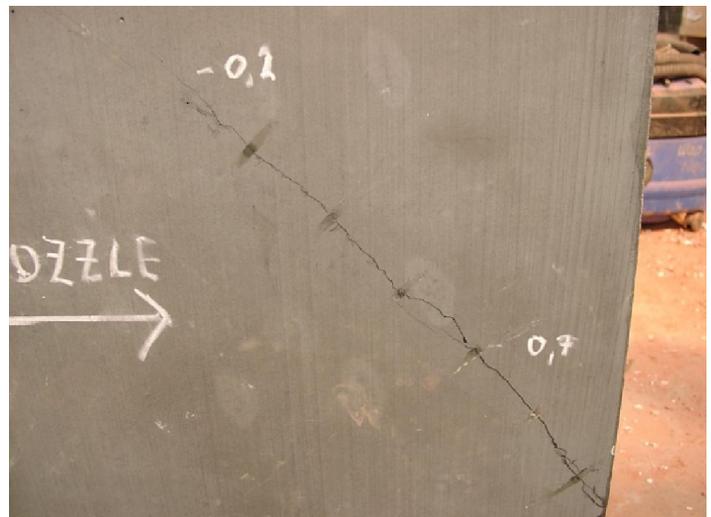
2) The crack was masked with a special tape whereby recesses were left open for the injection points. The injection with the MegaBond®-Injection-Process was carried out with rubber nozzles which were applied directly to the cracks. With a maximum pressure of only 1,5 bar the resin was injected. Uncontrolled discharge of the resin in the stele-inner was prevented through varying the injection intervals. After cleaning of the surface the crack is still visible but further calcium deposits are no longer possible.

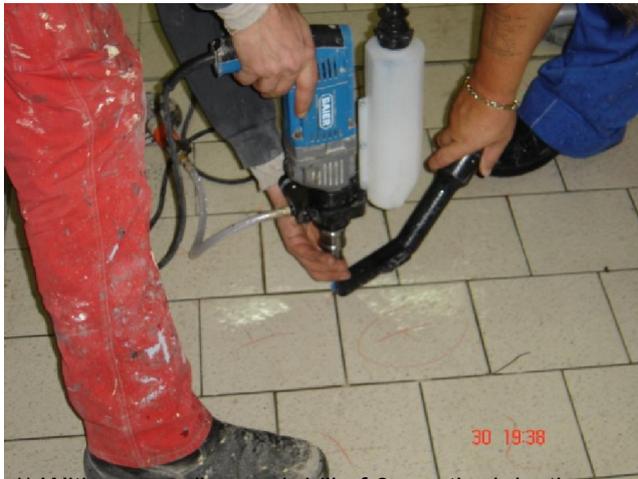
1) With a core diamond drill of 6 mm the injection points were drilled into the cross joints.

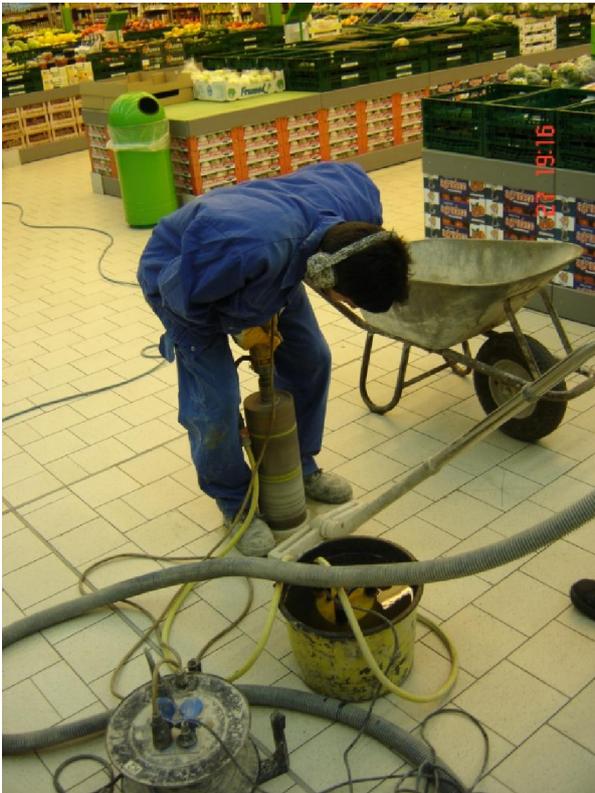
5) Taking a core drilling of 75 mm for a visual check of the resin penetration.

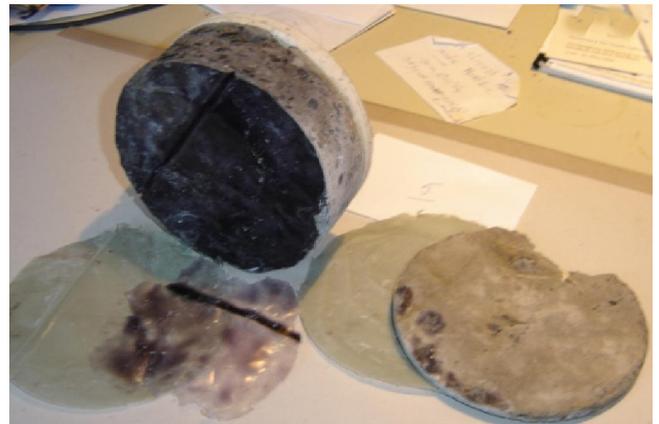
7) Core 5-3: Complete bonding and saturation of the screed. Resin penetrated fully through the separating foils.

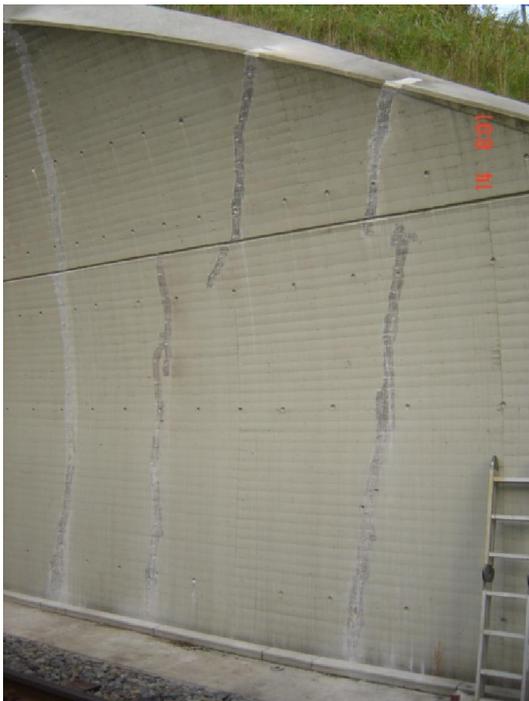
1) Uncover of crack surfaces. The calcium deposits were removed.

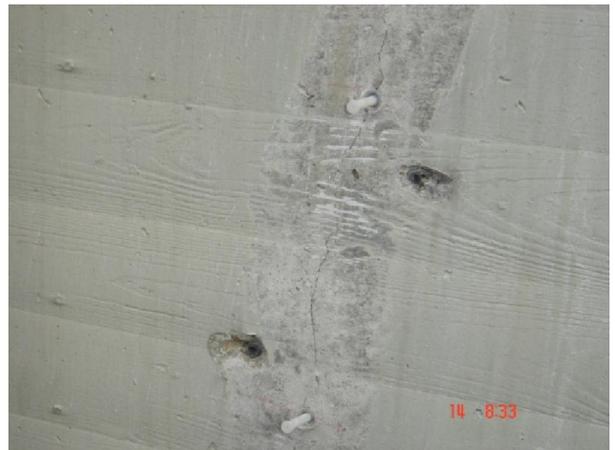
2) The first 5–10 mm of the crack depth is blocked by the calcium and also by resin from previous injection attempts. Clip pins are drilled in and fixed.

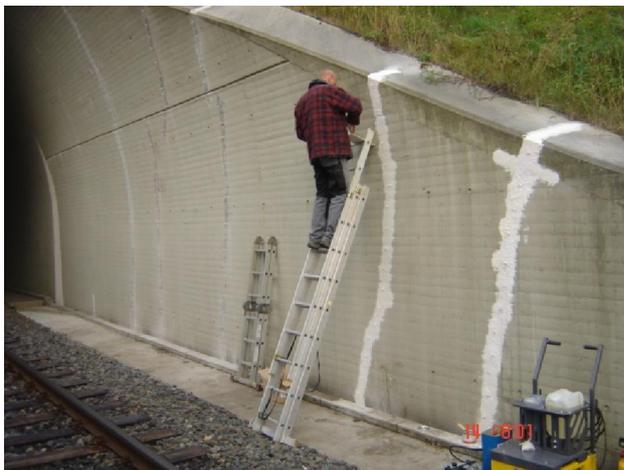
3) The fast hardening surface sealants are applied.

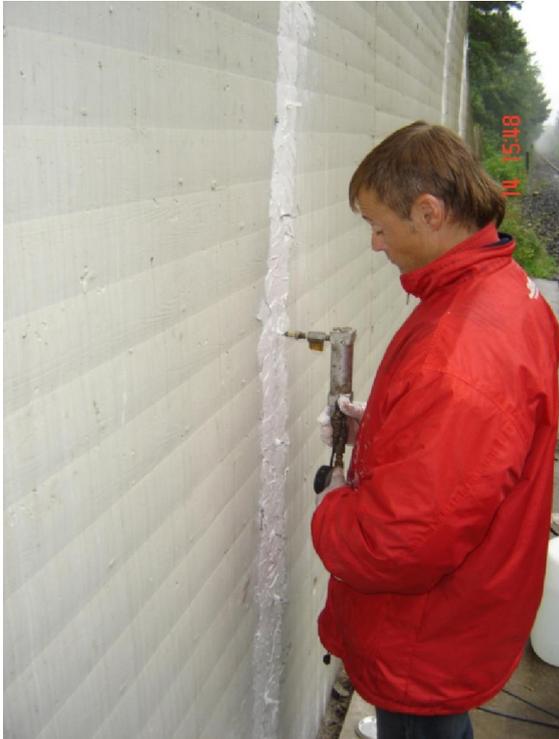
4) Injection process as per the 2 components low pressure procedure, the MegaBond®-Injection-Process

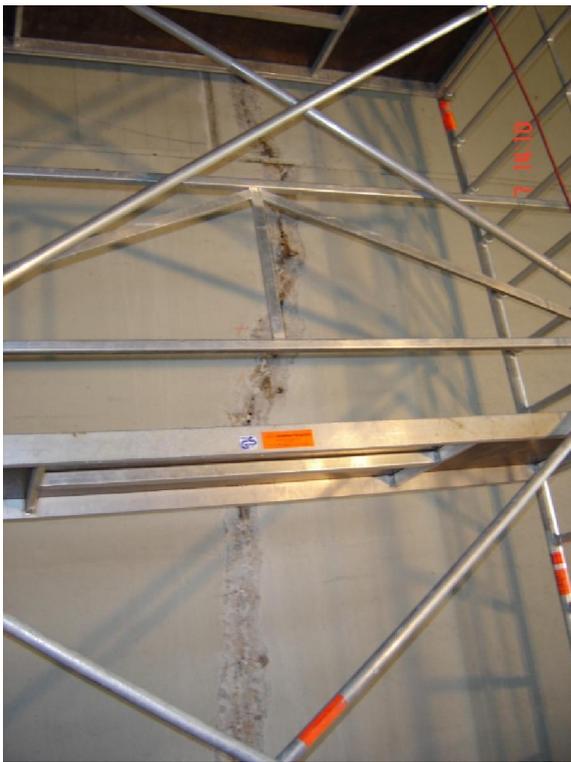
1) Uncovering crack.

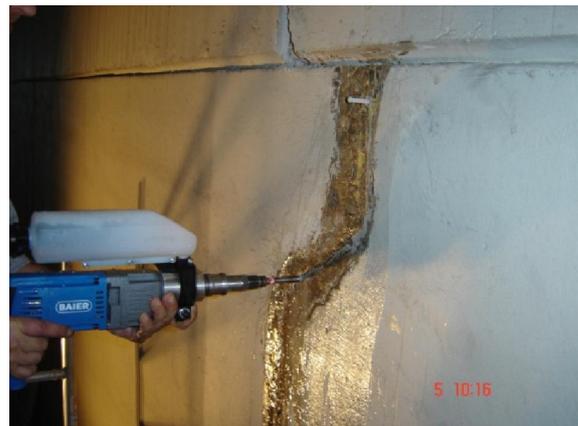
2) Drilling through blocked surface.

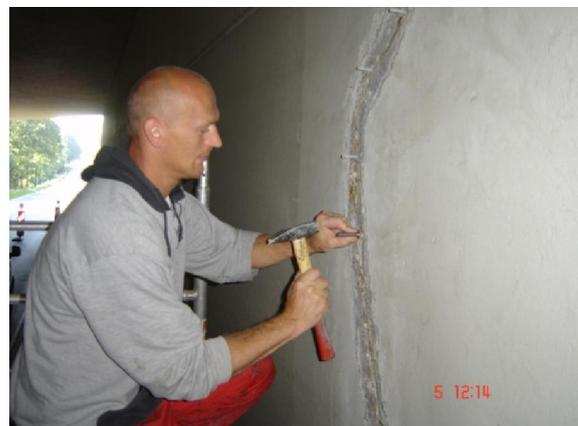
3) Setting the clip pins.

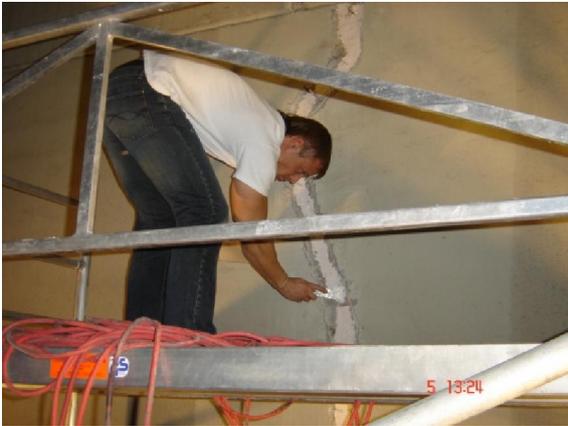
4) Applying the surface cover.

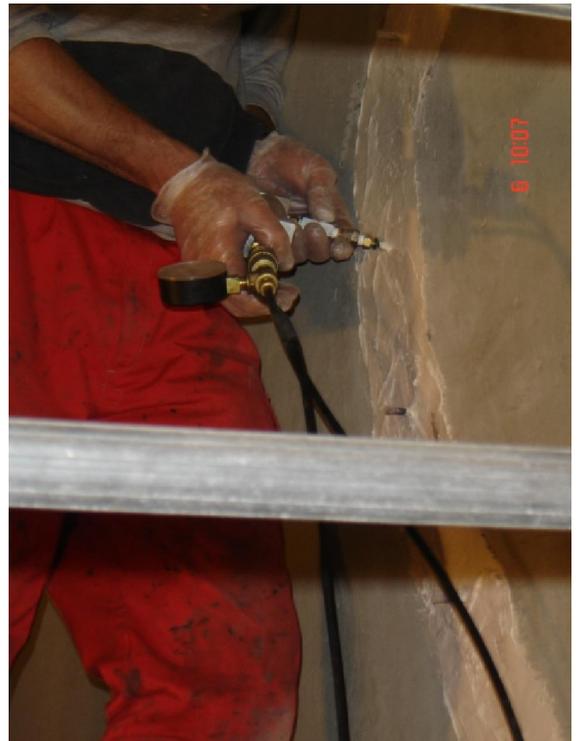
5) MegaBond®-Injection-Process

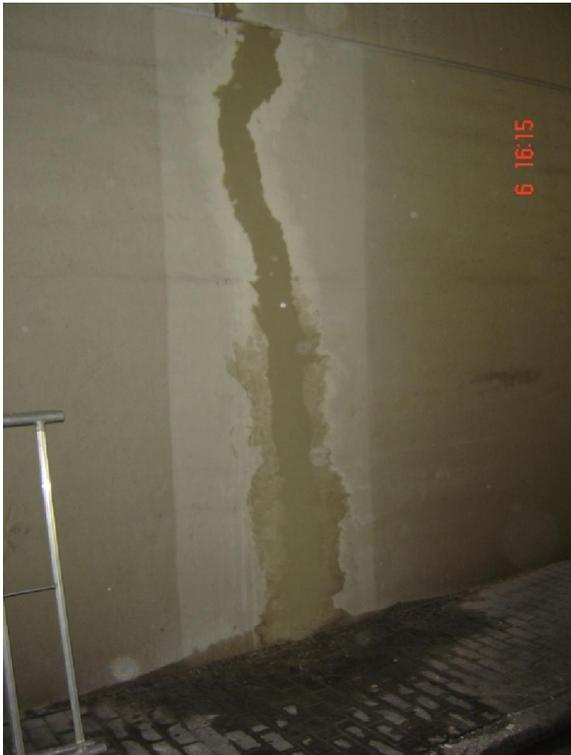
6) PCC-Coating in crack area.

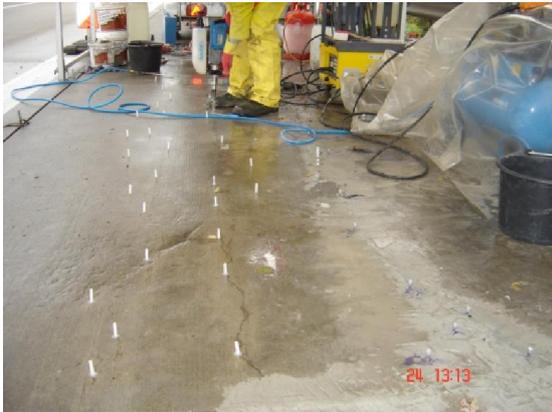
1) Taking the sample while it was rainy and cold.

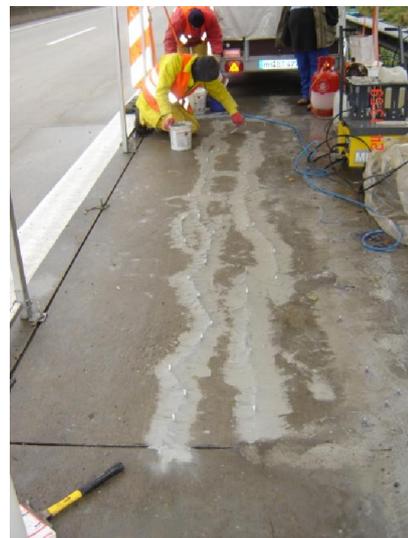
4) Applying the surface cover (2).

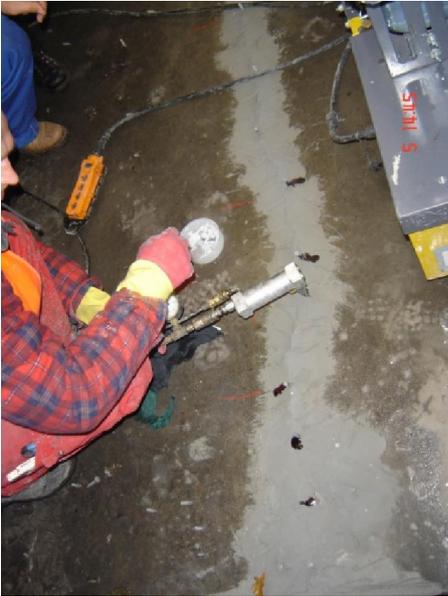
5) MegaBond®-Injection-Process

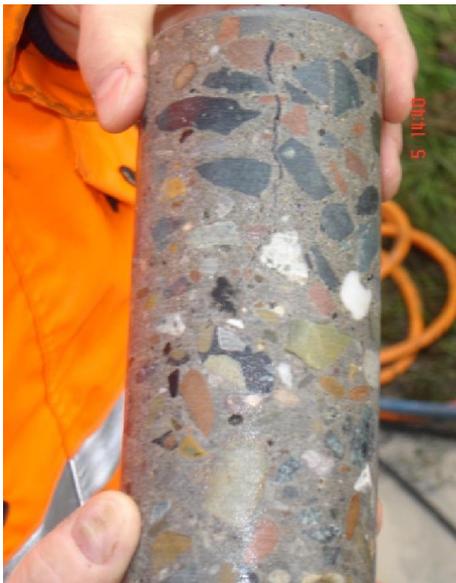
7) Penetration of resin to the lower concrete layer.

The cracks were blocked at the surface through tyre wear particles, sand and others.
Completion by temperatures around 4 °C.

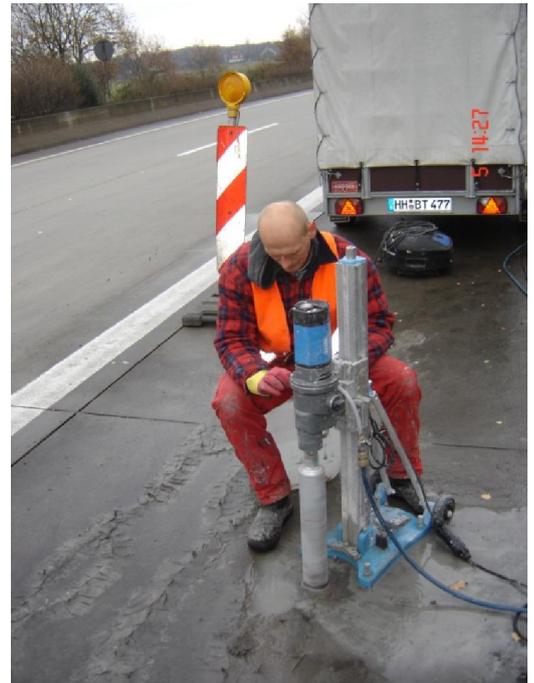
6) Core drilling DN 50 mm.

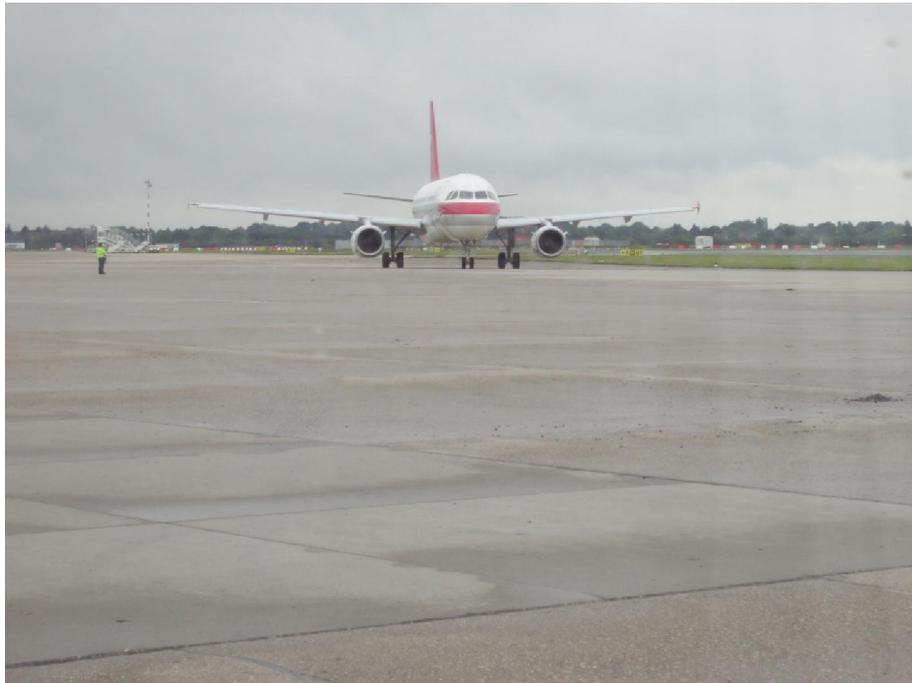
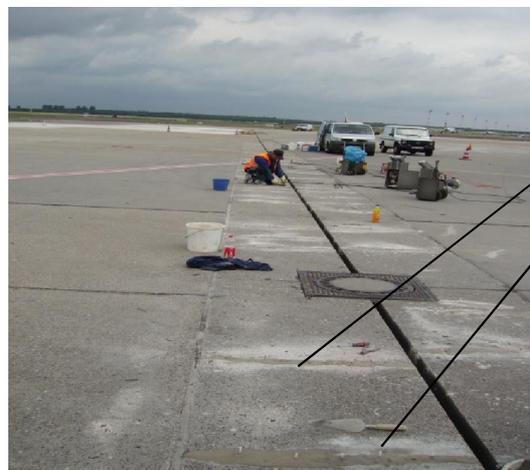
The runway showed 36 cm deep cracks in the concrete surface.

Here the surface cover was applied and the clip pins where set which are used for the admission of the resin.

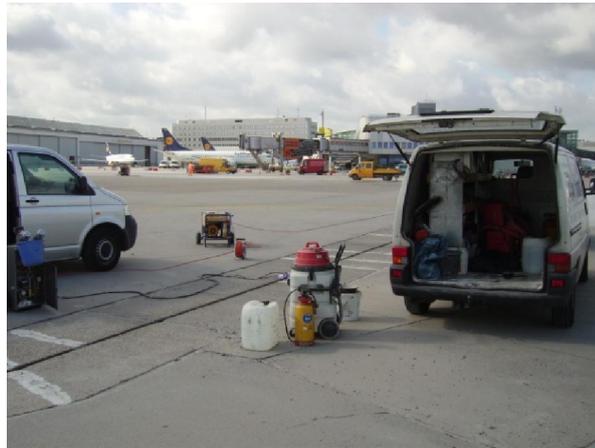
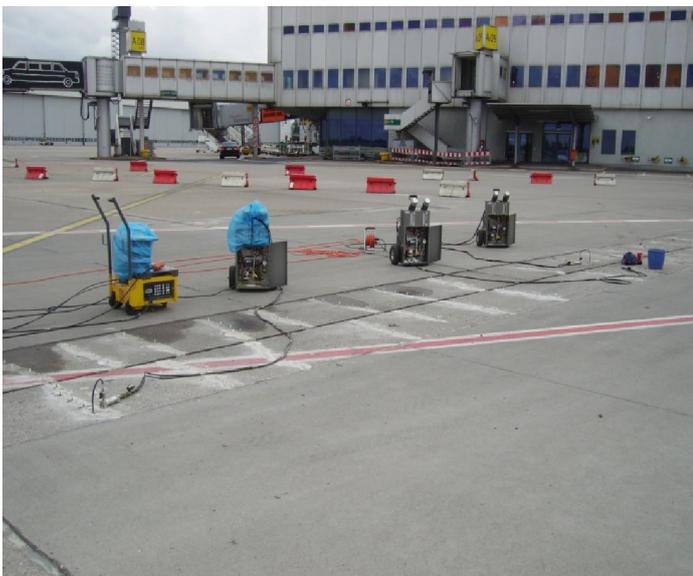
The cracks on the runway were injected to the full depth of 36 cm

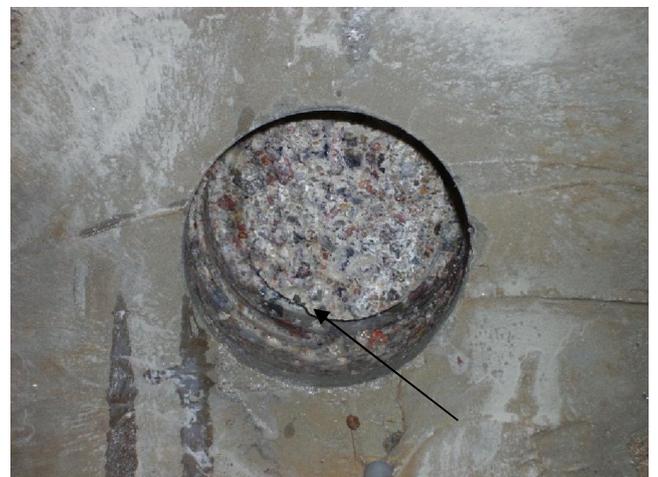
4) Core drilling after successful injection.
Crack width of approx. 0,1 mm completely filled.

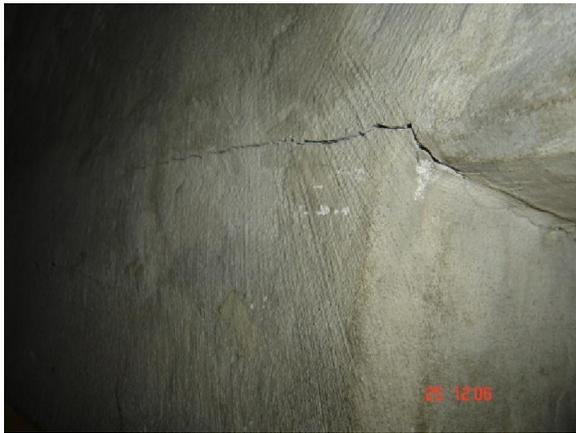
1) Corner-cracks in concrete wall, 2,5 m strong.

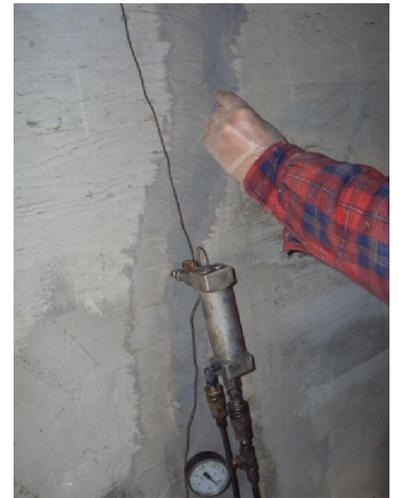
2) Crack sealed by the MegaBond®-Injection-Process with lowest pressure.

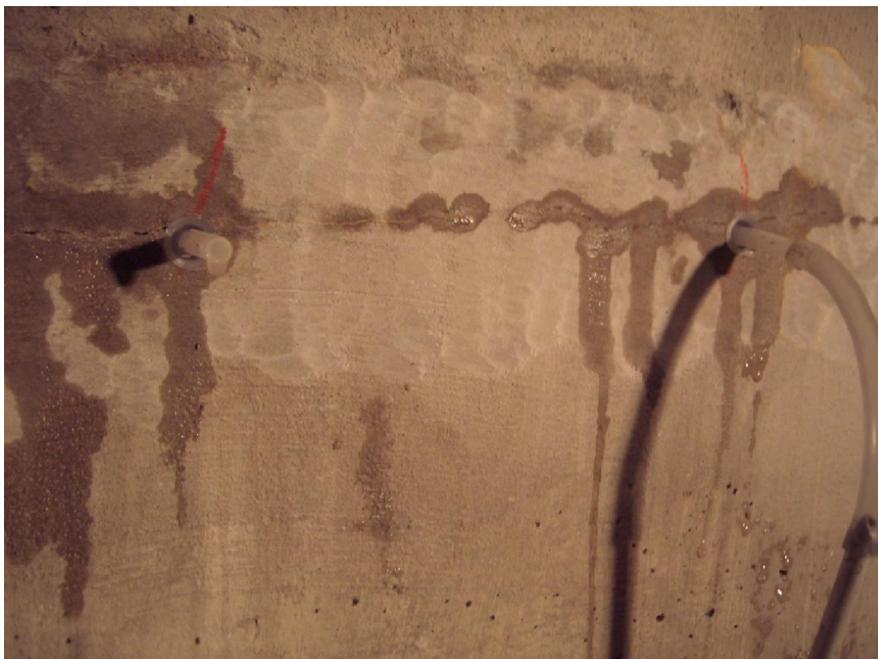
3) Water leaking out during the injection process. The resin pressed the water out of the crack!

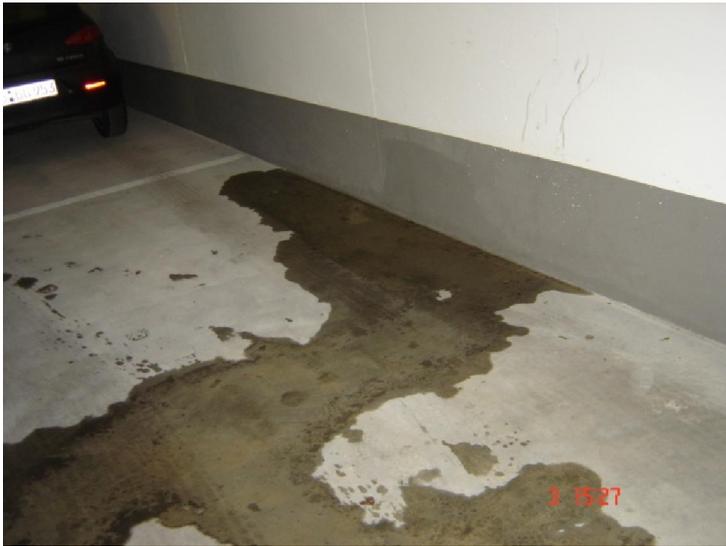
1) Water is seeping from the walls and ceiling.

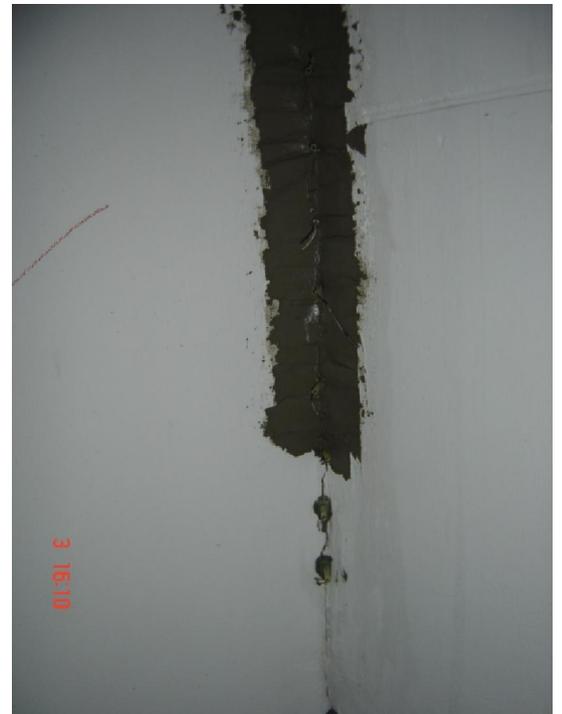
2) Surface cover of cracks is done to prepare for MegaBond®-Injection-

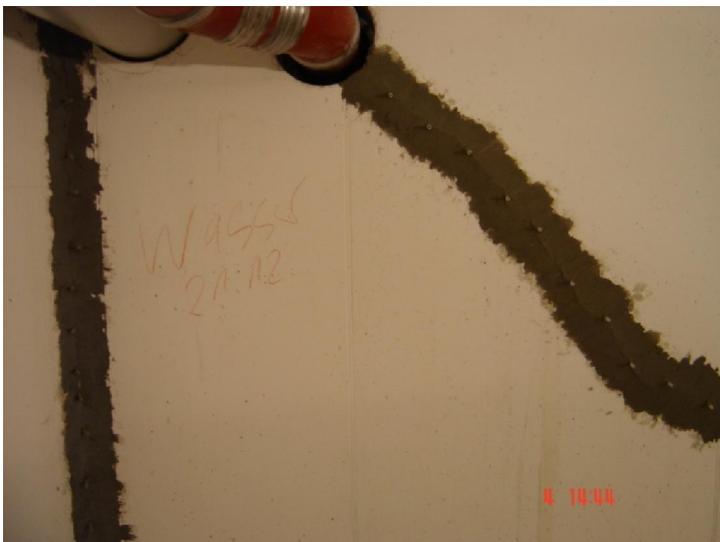
3) Preparational surface cover and setting the clip pins.

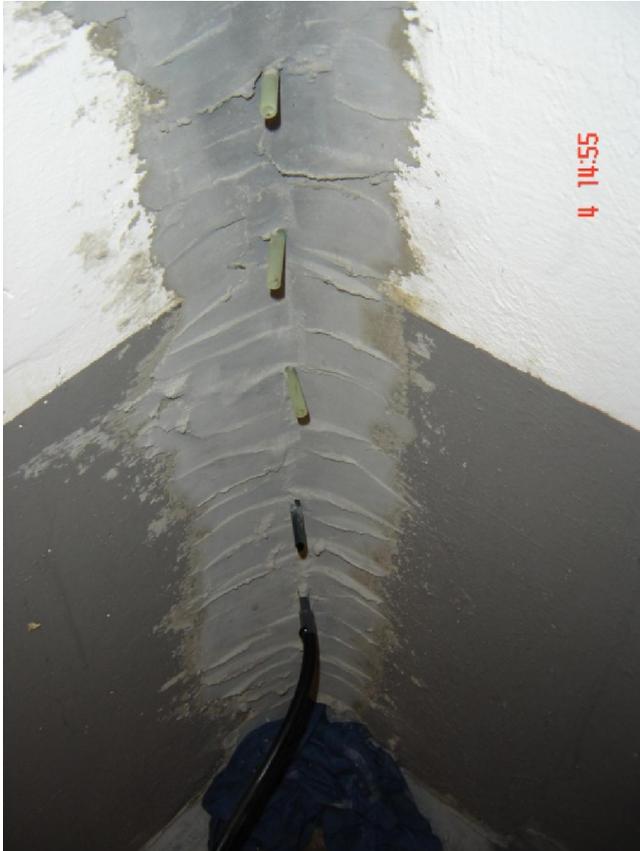
4) The injection was started at the lowest injection point. The resin pressed out of the next two pin points.

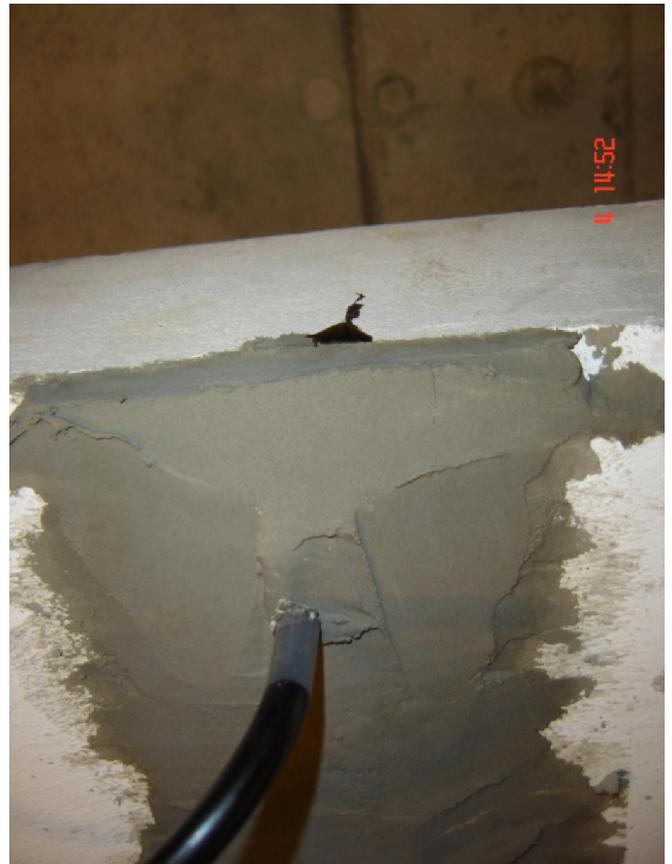
5) A micro crack of 0,1 mm in the window sill is injected.
One can see the resin flowing out at a non-sealed spot 15 cm above the pin.

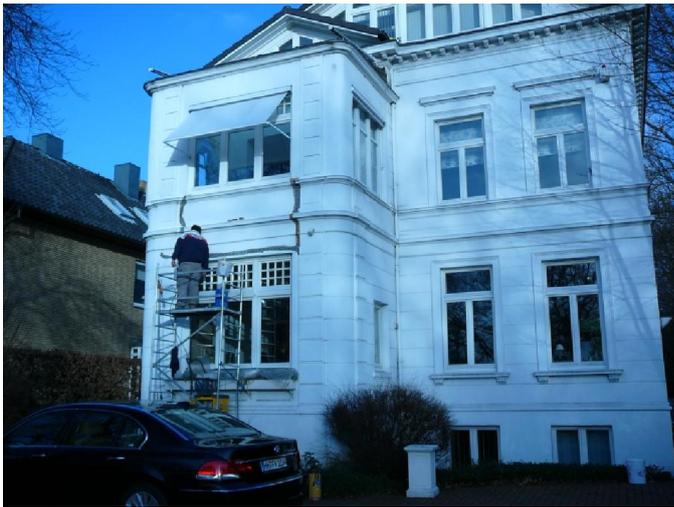
1) Here you can see the cracks between the windows and the bottom chord. These cracks were successfully repaired by the use of the MegaBond®-Injection-Process.

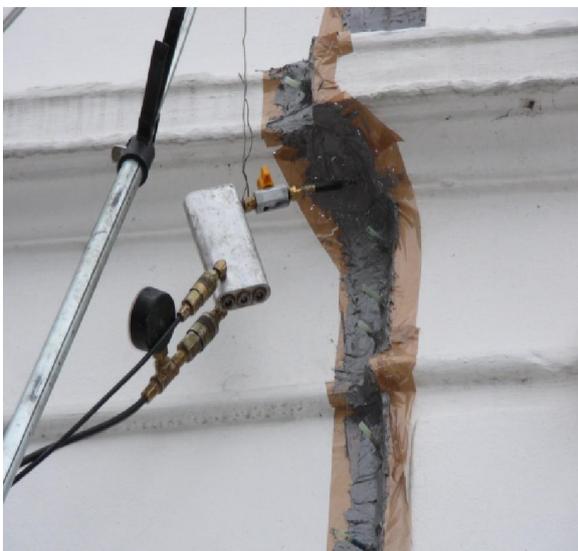
2) This crack was sealed before the injection was carried out. Here we injected with nearly no pressure.

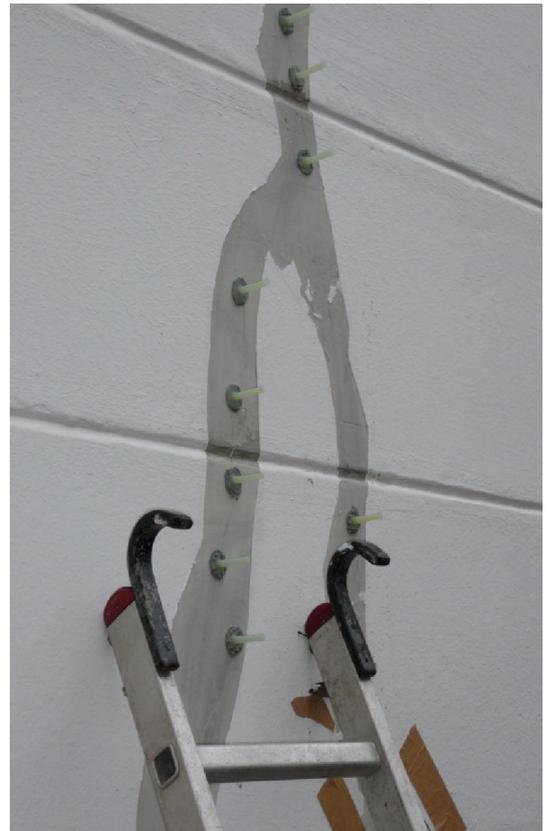
3) The crack in the facade has been sealed; the resin was injected through the pins. This is only possible with the MegaBond®-Injection-Process.

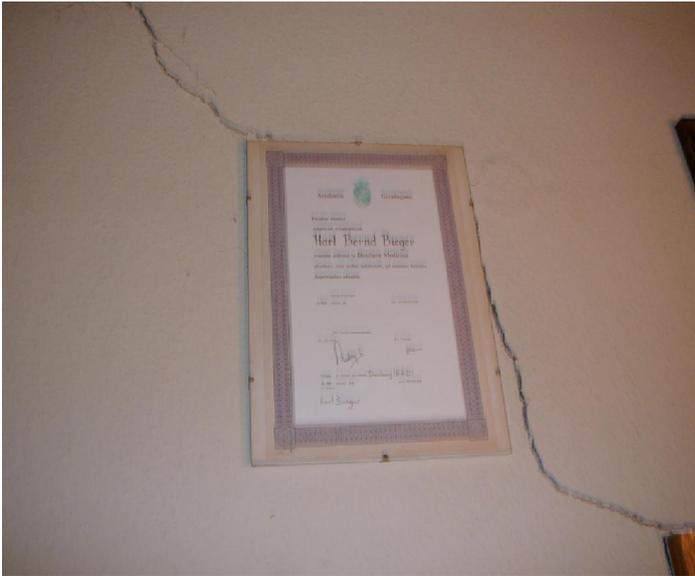
1) Crack in the living room. This crack was repaired force-fit by the MegaBond®-Injection-Process.

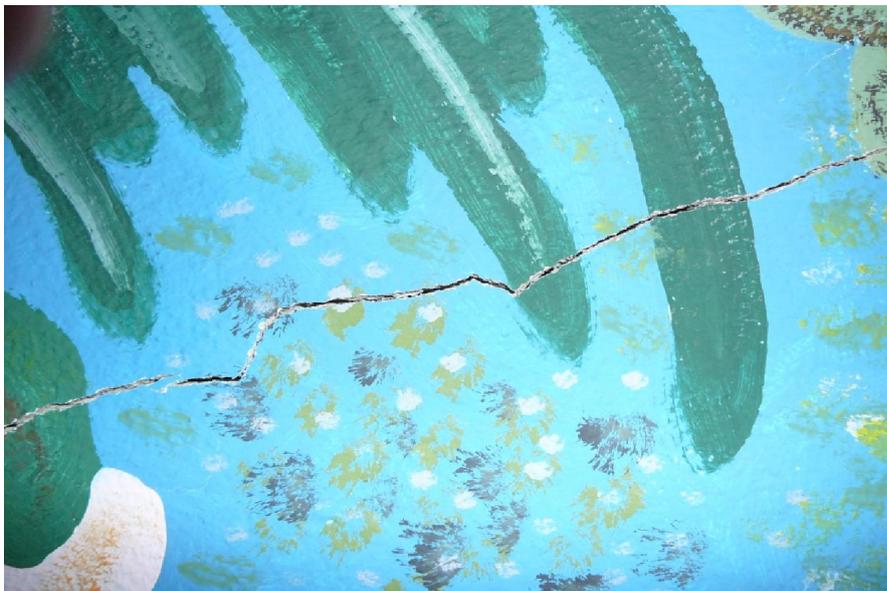
2) A continuous crack in the wall of a swimming pool. A force-fit injection should be carried out.
